## **Reassessing the Fluvial Geomorphology and Hydrology of Pipers River, including Rehabilitation Outcomes – Project Outcomes**

My name is Matthew Tedford and I am a student at the University of Tasmania, based at the Newnham Campus. Over the past six months I have been researching Pipers River as part of the final subject of my undergraduate degree, Bachelor of Applied Science – Environmental Science. With help from Tamar NRM and the Christopher Strong Fellowship, I was able to complete this report, which will be featured in a scientific journal in the near future. The following is taken from the abstract of my report, “Reassessing the Fluvial Geomorphology and Hydrology of Pipers River, including Rehabilitation Outcomes”.

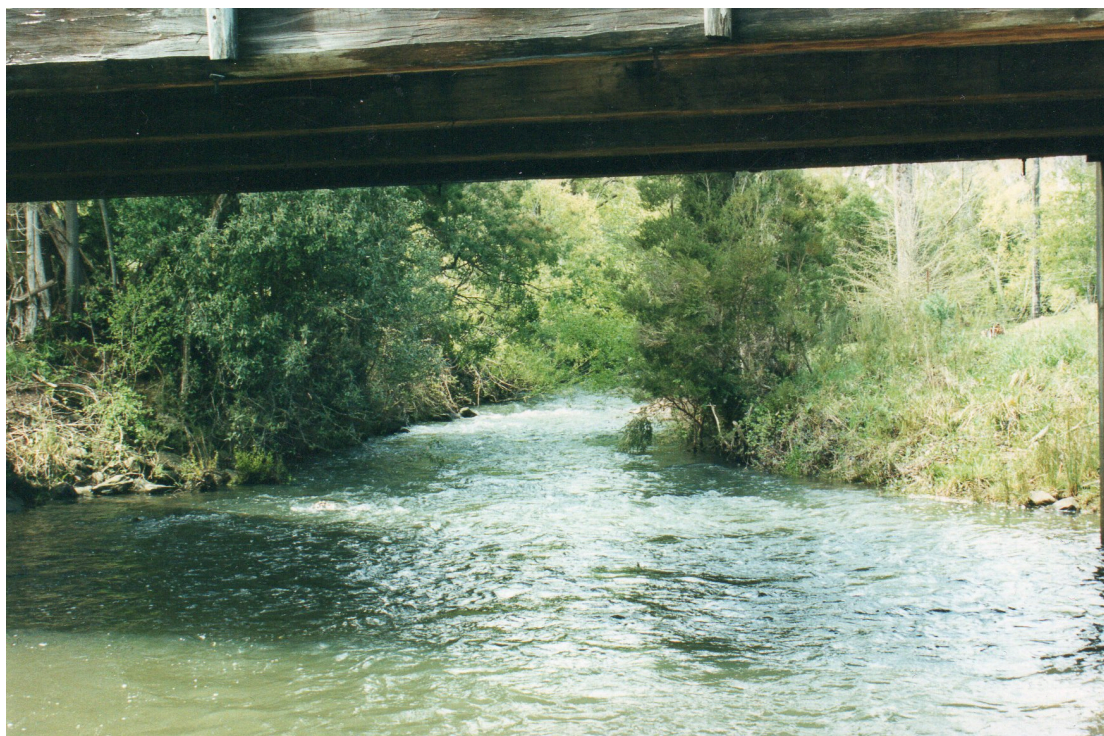
Underwood site looking upstream, 2000. Credit: East Tamar Landcare Group

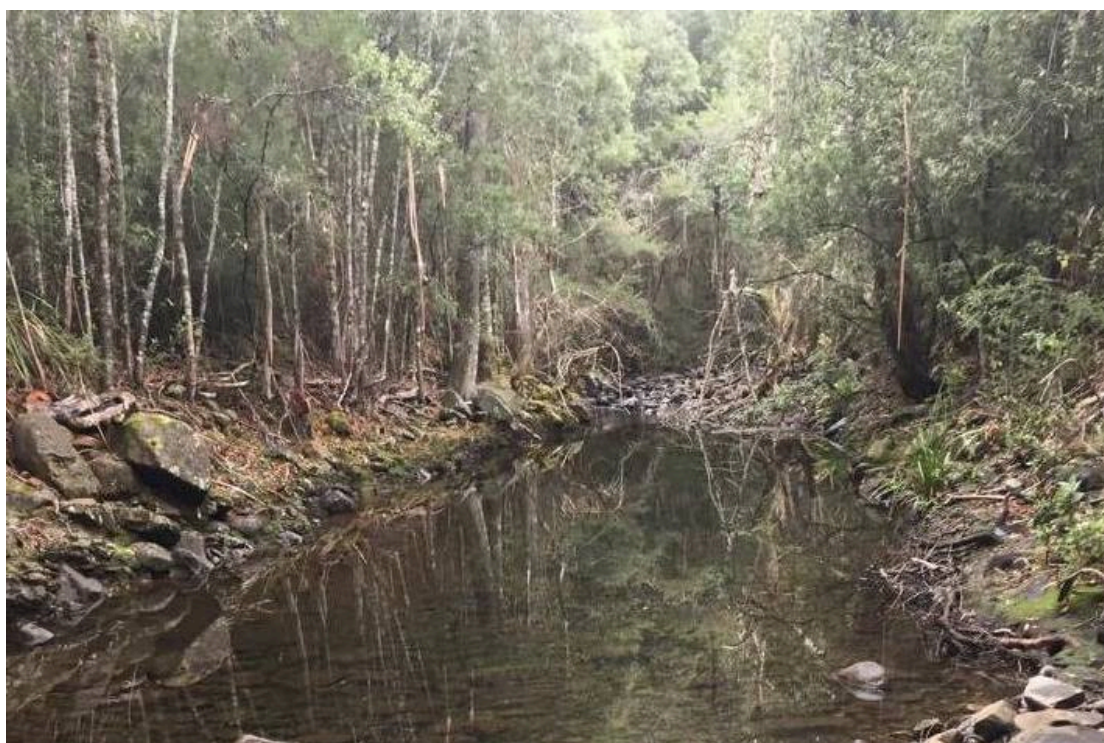
Underwood, the most natural, biologically diverse and protected of the four sites, was stable with little change to its bankfull cross-sectional area, decreasing in velocity and discharge over time with a constant subcritical, laminar flow. Collins Rd, under anthropogenic pressures, gives a bankfull cross-sectional area that indicates river change as it deepens with losses of sediment from the riverbanks, although velocity and discharge have decreased more than that of Underwood, with a once subcritical turbulent flow downgraded to subcritical laminar flow. Colgraves Rd, also under anthropogenic pressure, has accreted sediment over time as seen by the bankfull cross-sectional area. Velocity and discharge have increased dramatically, maintaining a subcritical turbulent flow that is destined for future erosional problems. Baxters Rd, the site of heavy rehabilitation by Willow tree removal, has lost significant cross-sectional area where this has taken place. In saying that, velocity and discharge have decreased, but the laminar flow recorded in 2000 is now classified as turbulent flow as of 2016.

Underwood Site looking upstream, 2016. Credit: Matthew Tedford

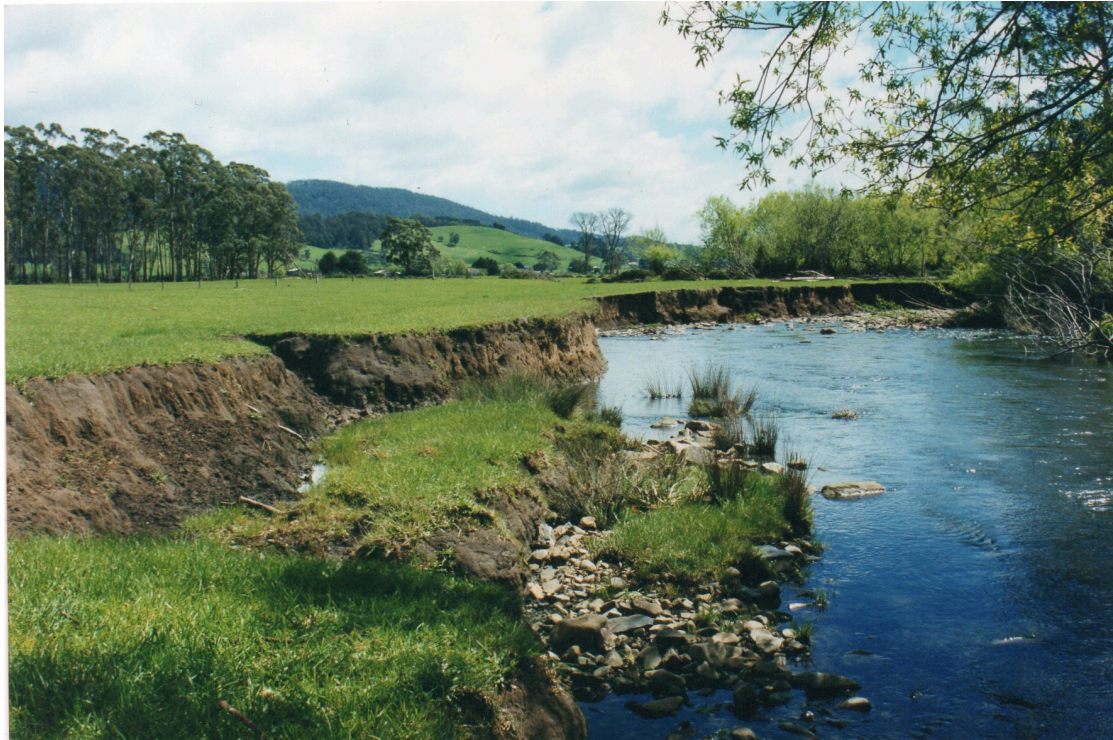
Collins Rd site looking downstream, 2000. Credit: East Tamar Landcare Group

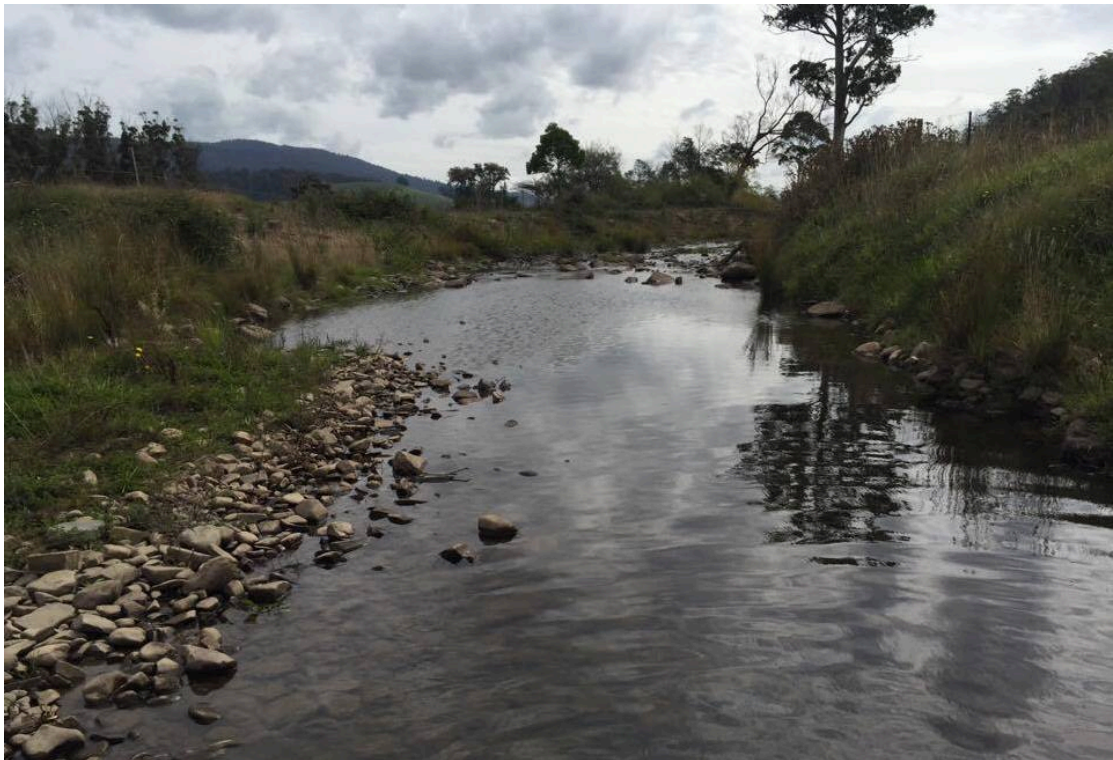
Collins Rd site looking downstream, 2016. Credit: Matthew Tedford

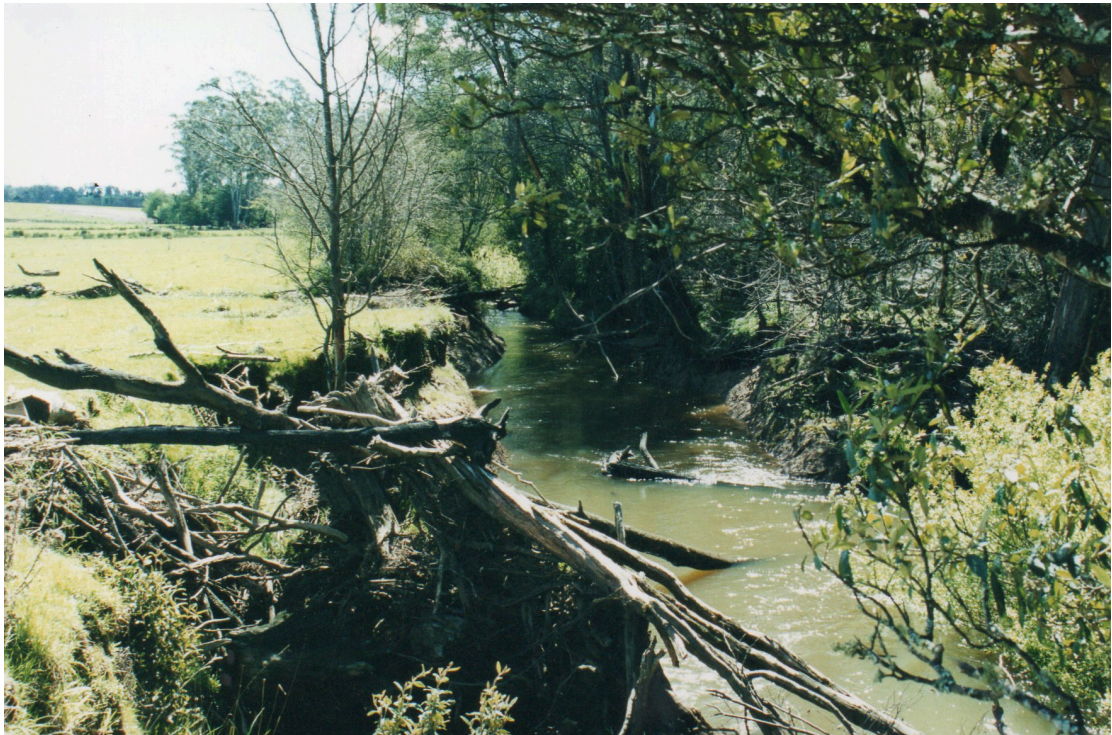
Colgraves Rd looking downstream, 2000. Credit: East Tamar Landcare Group

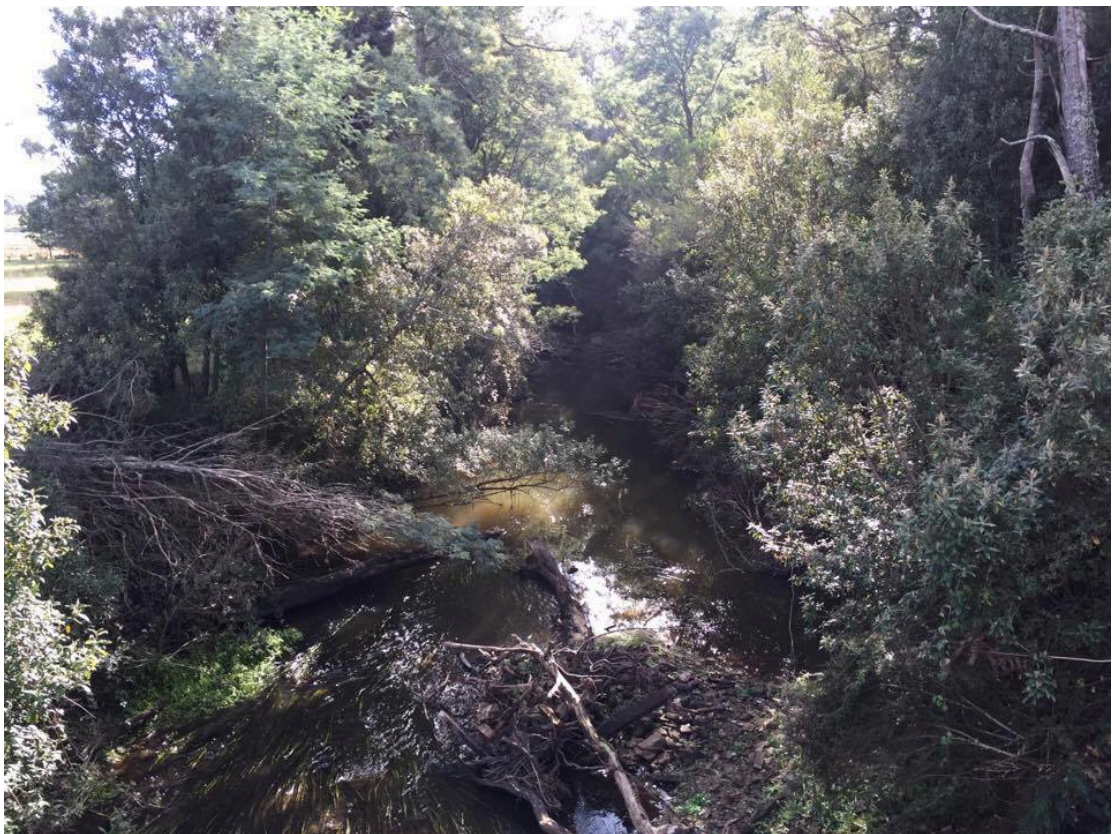
Colgraves Rd site looking downstream, 2017. Credit: Matthew Tedford

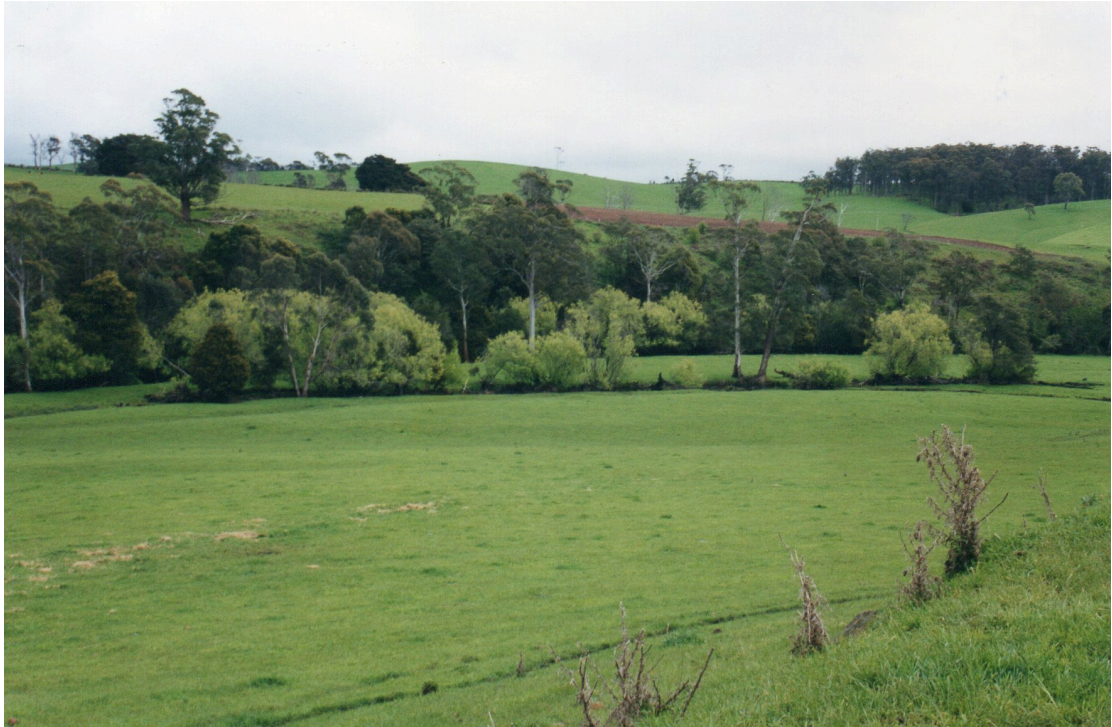
Baxters Rd site, 2000. Credit: East Tamar Landcare Group.

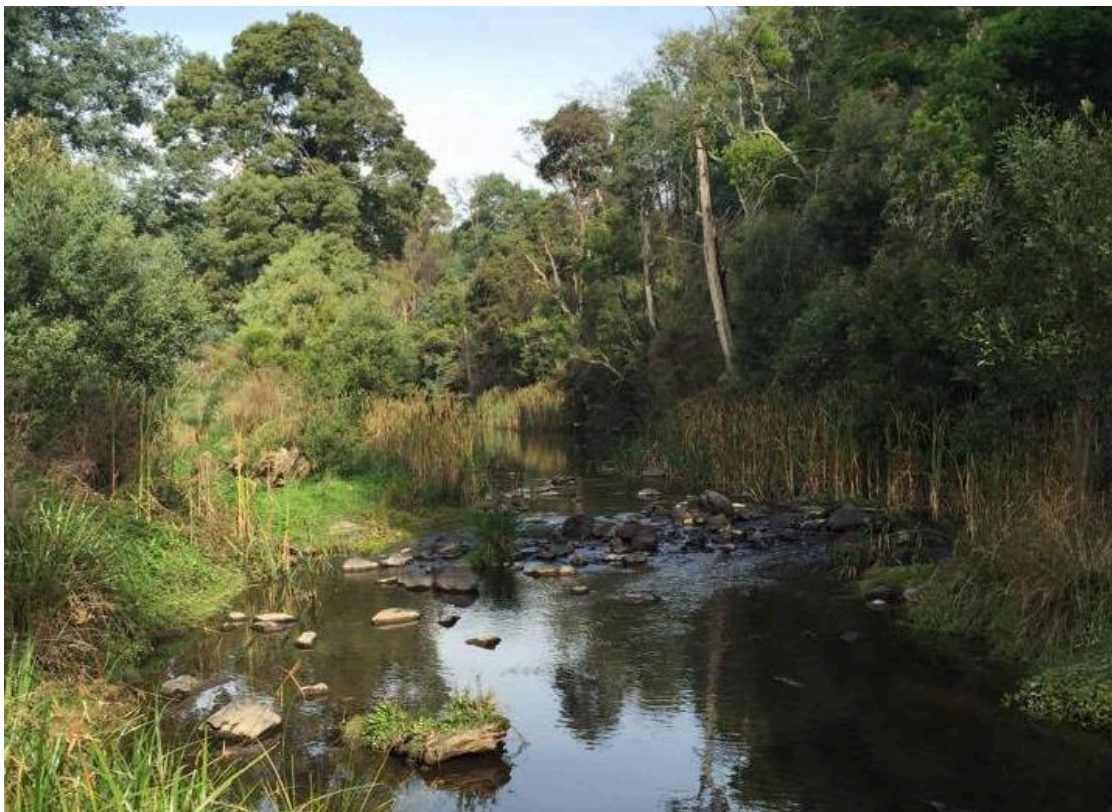
Baxters Rd site looking upstream after rehabilitation, 2016. Credit: Matthew Tedford

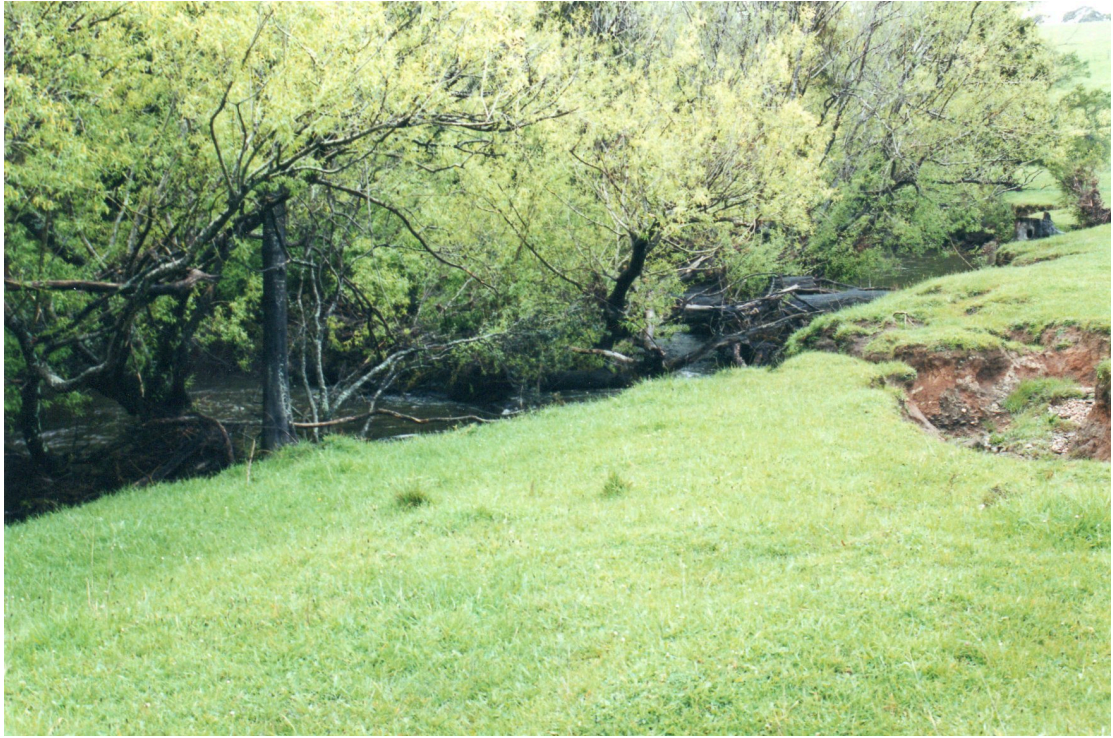
Willow damage.

From the results found, it can be concluded that more research is required to determine the long-term effect of Willow removal on riverbank sediment loss. To prevent further loss and damage to erosion-prone areas, adequate fencing of riparian vegetation of up to ten metres behind the river line is recommended. This will prevent further damage to the river by means of excluding the presence of stock. By doing so, the riparian zone is able to acquire native vegetation naturally by means of hydrochory during times of high flow. For an increased recovery time, planting of native vegetation specific to the area can be effective, bringing the riparian zone back to the healthy state that it once was.

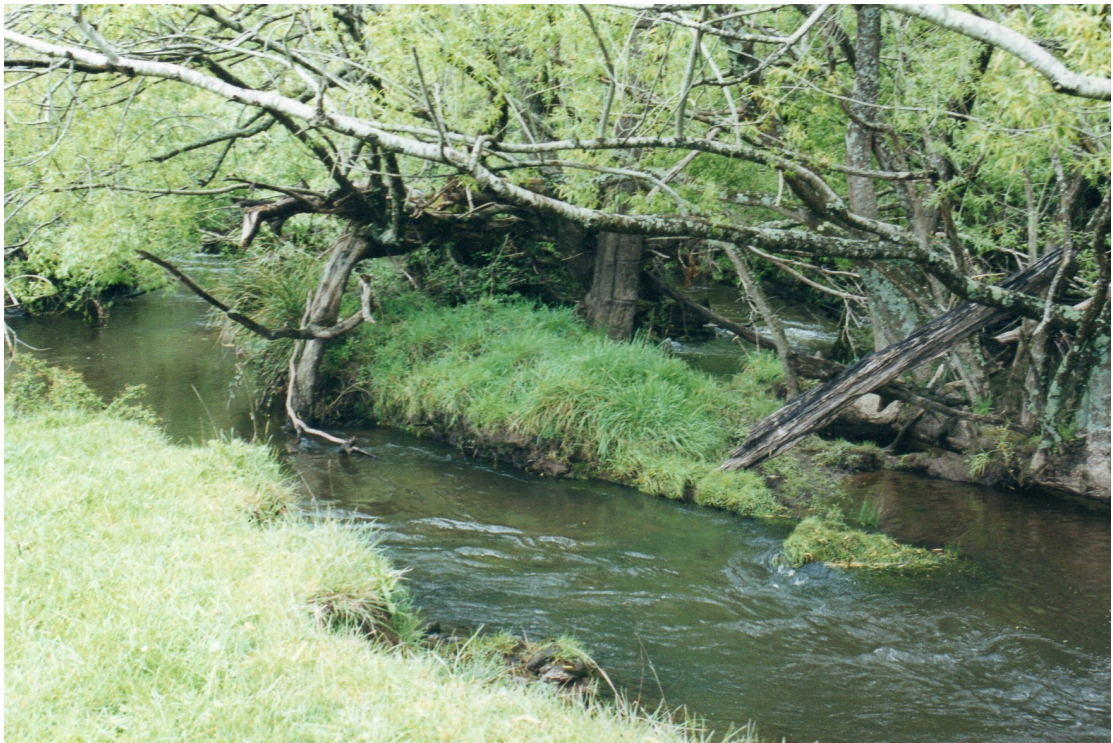
In-stream island created by willow infestation.
