Assessing and maintaining the coastal stability of Weymouth Beach, Tasmania

Lochlan Skinner 186985

23-Oct-15

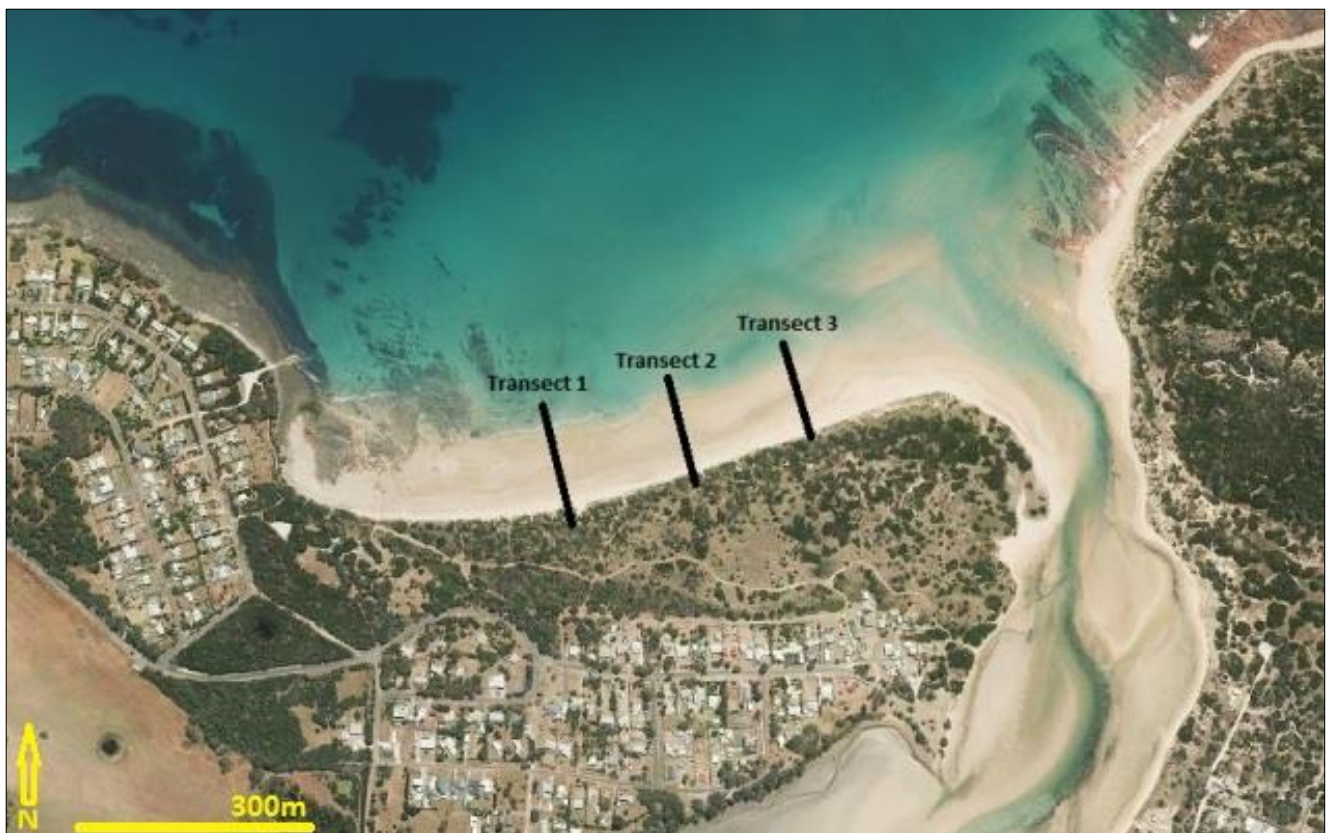
Figure 6: Location of WB three analysed transects, photo courtesy of The George Town Council (2015) [edited by Skinner, 2015].

The cross-sectional survey and sediment analysis of WB was conducted under the supervision of Joanna Ellison. This survey was taken from three datum points along WB, set by the Weymouth Progress Association. These transects were taken on the 24th of April 2015 during low tide, at 12:45pm. These transects were completed as a university class study for the unit 'KGA 326: Environmental Geomorphology', to display the distance and variances in elevation, from the datum points/hind dune to the low tide mark. These transects were made by three different groups, which may cause variances. The transects overall purpose is to reaffirm what is seen in the aerial photographs and to provide some context when discussing the sediment analysis and the multivariate nature of coastal stability. Ultimately, these transects aim to provide baseline data for the quantitative analysis of WB geomorphology.

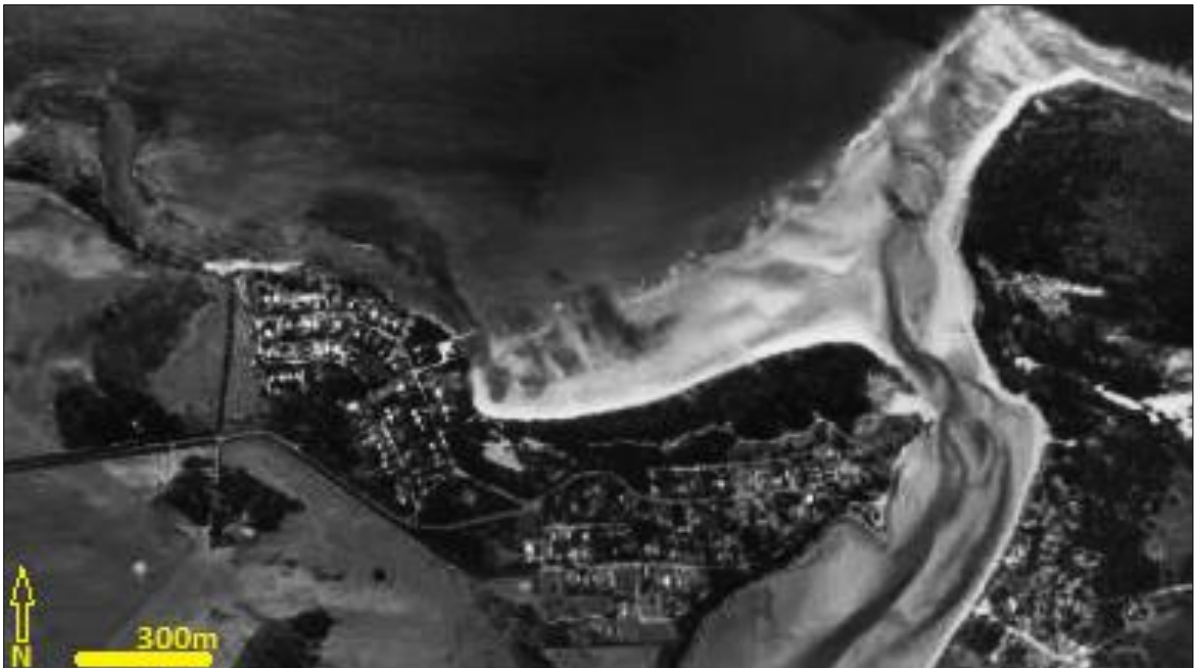
Figure 8: The Weymouth area (1980) displaying increased urbanisation, a vegetated dune system and a receding fore dune. Figure source: Land Tasmania (2015) [edited by Skinner, 2015].

The timeline (Figures 7-11) used aerial photography to demonstrate the progression of the WB dune system, in relation to vegetative cover and increasing urbanisation. These factors are highly influential on coastal stability (DTAET, 2007) and are thus significant in the WB coastal stability analysis. Furthermore, the shading of the estuary's channel indicates varying depth. The increased presence of grey silt and quartz in the channel has also been noted by kayakers and locals (Survey participant, pers. comm., 2015).

The aerial imagery of WB (Figures 7-11) has indicated a trend, between increased vegetation and urbanisation to the receding dunes and the coastal instability of WB. Vegetation is often associated with coastal stability; when more people populated Weymouth there was an increased value for the coastal stability of WB. Consequently, vegetation was planted on the dunes to stabilise WB and to protect its inherent values (Figure 7 and 8). At the time, marram grass was understood to enhance coastal stability, through its effectiveness in retaining dune sediment (Rudman, 2003; Hayes and Kirkpatrick, 2012). Understandably, the contrast between Figures 8 and 9 display a change in vegetation density. Marram grass is known to naturalise its new coastal environment (Jenks, 2014), in doing so it has dramatically altered the dune system of WB (Figures 8-11); The vegetation increase (Figures 8-11) indicates the change in the hind dune's presence (Figure 5); the naturalisation of WB, by marram grass, has seen the forest and hind dune replace the fore dune of 1949 (Figures 7-11). As a result, the previous location of the hind dune in 1949 has de-elevated and the now undercutting hind dune of marram grass, consequently leaves Weymouth increasingly vulnerable to flooding. Evidently, this plantation has become counterproductive for coastal stability (Figures 7-15

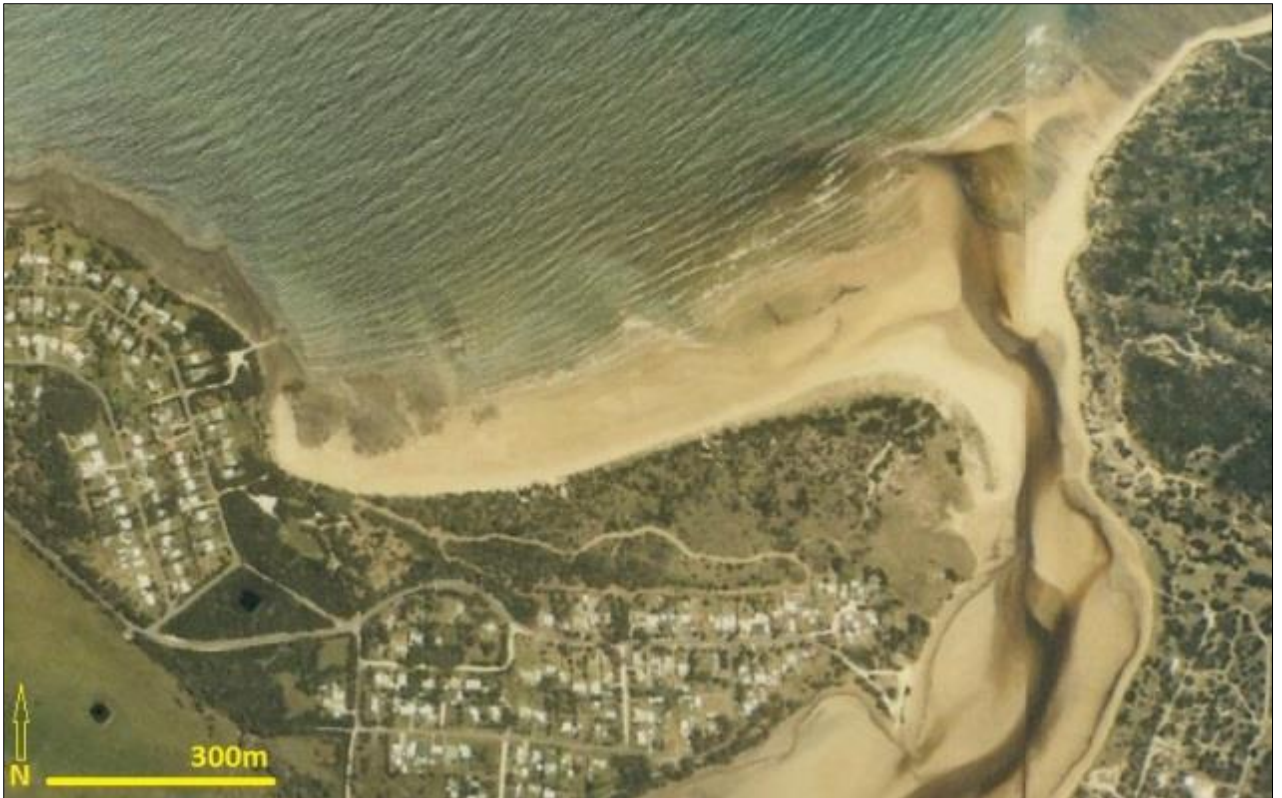
Figure 9: The Weymouth area (2005) displaying a heavily receded fore dune and reduced hind dune vegetative cover, courtesy of The George Town Council (2015) [edited by Skinner, 2015].

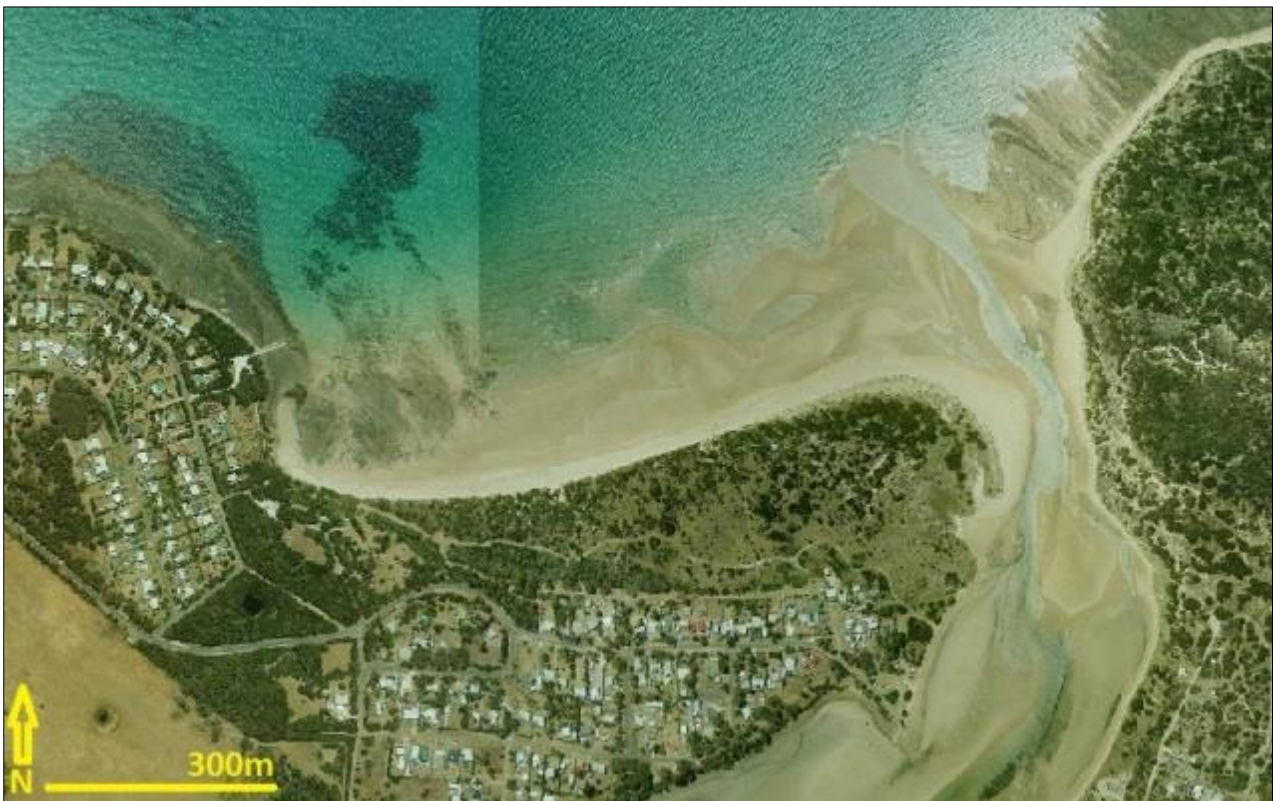
Figure 10: The Weymouth area (2010) displaying the absence of a fore dune, courtesy of The George Town Council (2015) [edited by Skinner, 2015].

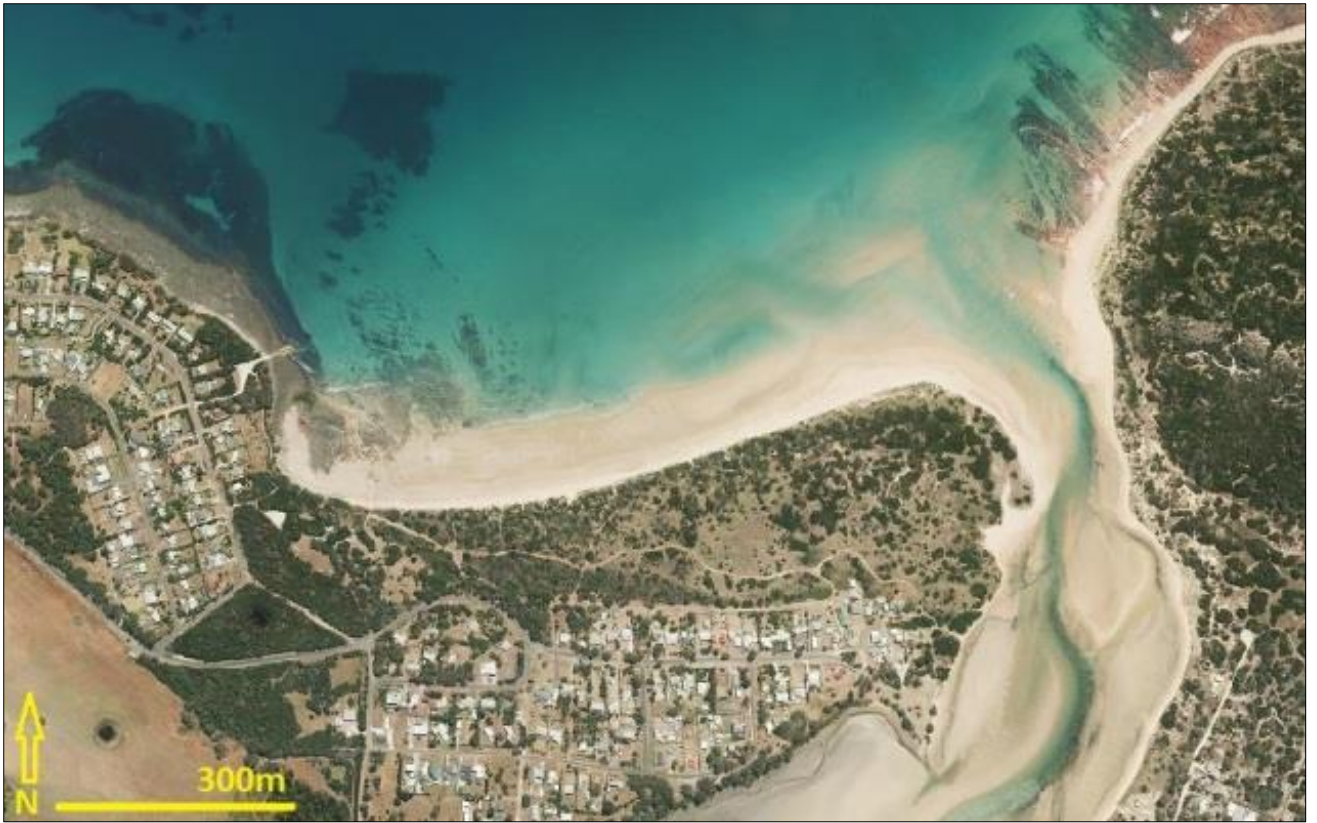
Figure 11: The Weymouth area (2014) displaying steepening of the hind dune, courtesy of The George Town Council (2015) [edited by Skinner, 2015].

Figure 11 indicates there is approximately 120 m of dune system remaining at WB. As a result, the WB dunes would take 63 years to erode away from sea-level rise, per se. Understandably, sea-level rise will bring added pressures to maintaining coastal stability (Bosello and De Chian, 2014; White et al., 2010; McInnes et al., 2012).

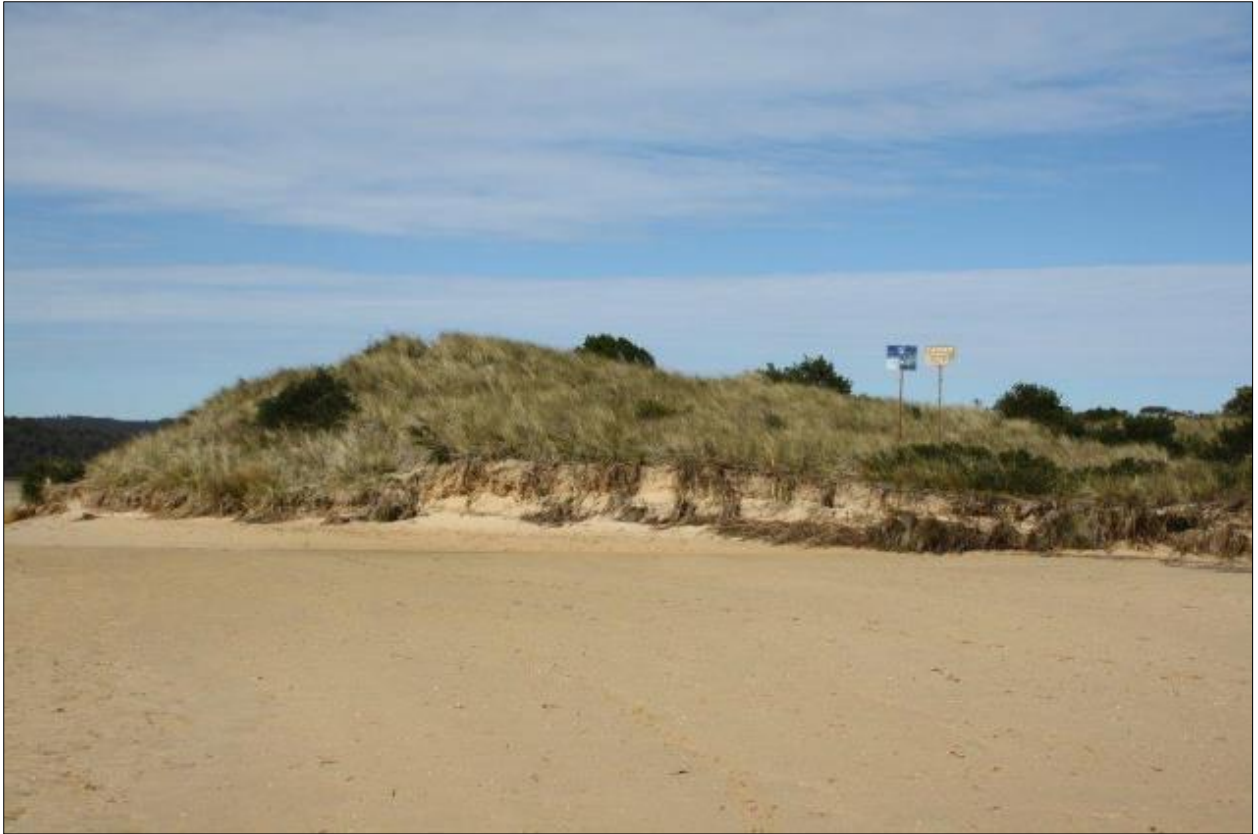
Figure 12: Weymouth's eastern most dune (2009), next to the estuary mouth. The dune is undercut and dominated by marram grass, courtesy of Lindal Byard.

WB physical response to these storm events has proven to be poor (Figures 12 and 13). At present, Figure 16 and 18 show the presence of a minor dune. When compared to Figure 19 and Table 1, it is confirmed that these minor dunes are the product of a recent storm event; coarse sediment is indicative of a recent deposition (Krumbein, 1941) and the calcium carbonate depicts an oceanic origin (Biscaye et al., 1976). Evidently, WB is prone to storm events which can both erode and dispose sediment. This is important in managing the coastal stability of WB, since pioneering species, can take advantage of this new disposed sediment quickly (Figure 23). The issue is thus to compose WB with the right pioneering, native species, such as spinifex (*Spinifex sericeus*) and austrofestuca (*Austrofestuca littoralis*).

The present vegetative composition of WB has effectively disabled WB capacity to retain sediment (Figure 12 and 13). As shown in Figure 25, the Bellingham dunes orientation makes it susceptible to coastal erosion from the prevailing SACW and SASW currents (Figure 2). A north-south orientated groyne, positioned on the western side of the estuaries mouth would retain sediment for WB, while breaking the wave energy of the prevailing currents on the Bellingham dunes. The construction of groynes, such as the previous Tea tree groynes in the estuary, can be both low in cost and effective. Yet locals are concerned that groynes: hinder recreational value, are easy to stub their toes on and provide a navigational hazard (Survey participant, pers. comm., 2015). This can be overcome with a fluorescent flag protruding from the groynes, though this may degrade WB aesthetic value. Furthermore, since WB

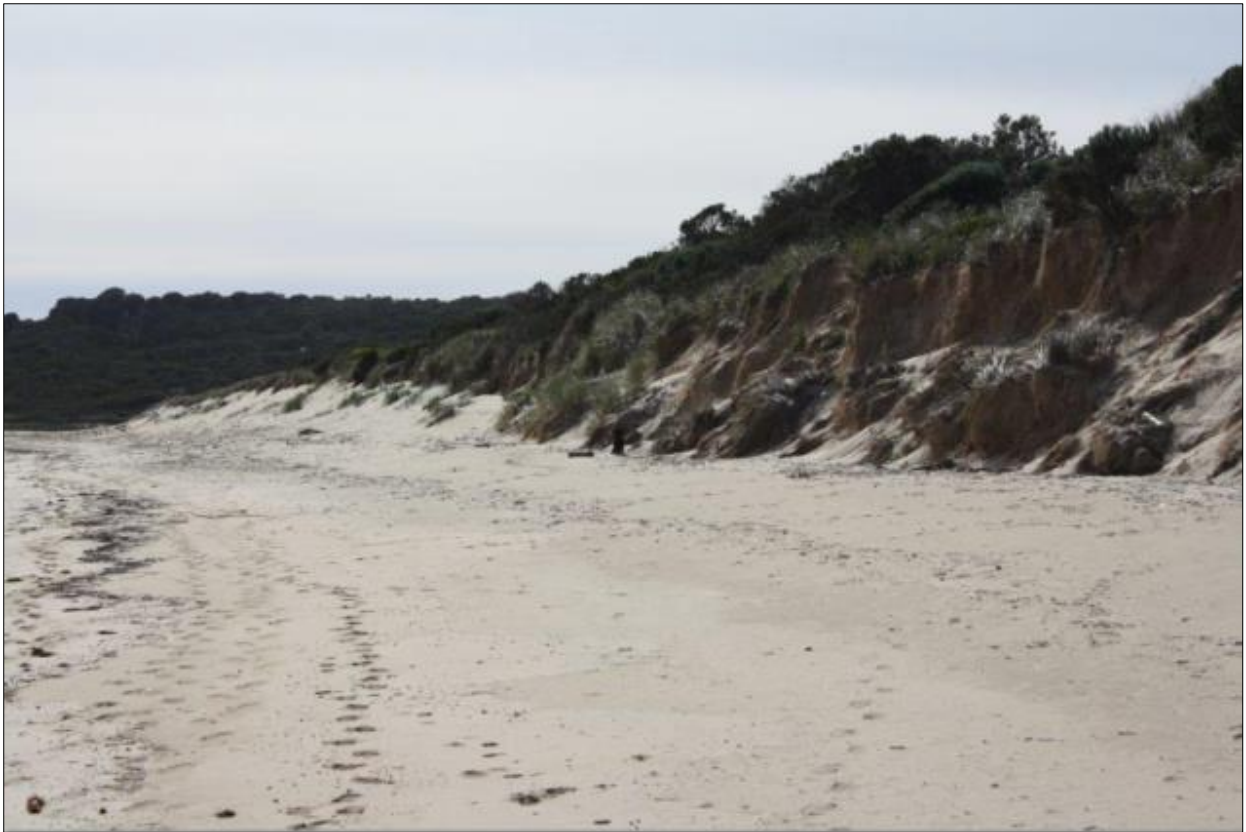
Figure 13: Weymouth's eastern most dunes (2009), displaying the widespread undercutting and dominance of marram grass, courtesy of Lindal Byard.

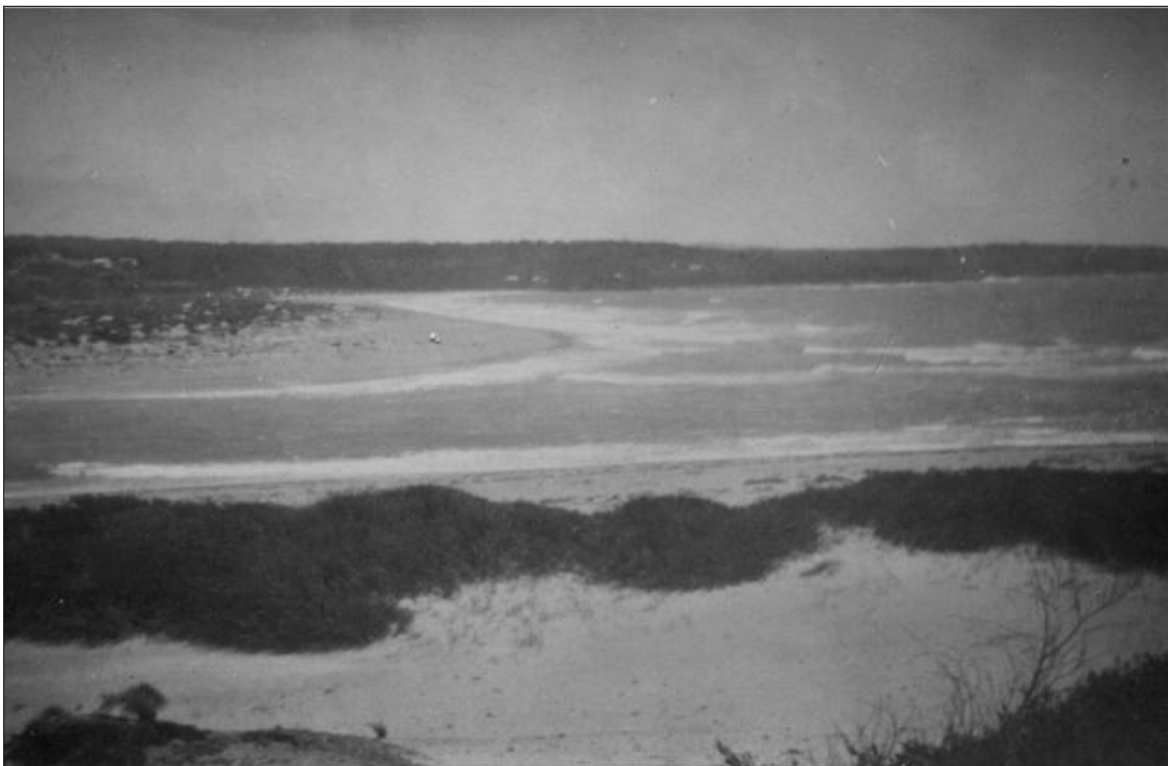
Figure 14: View of Weymouth beach from the Bellingham dunes (early 1960's), displaying a steady slope from the eastern most dune to the estuary mouth, courtesy of Lindal Byard.

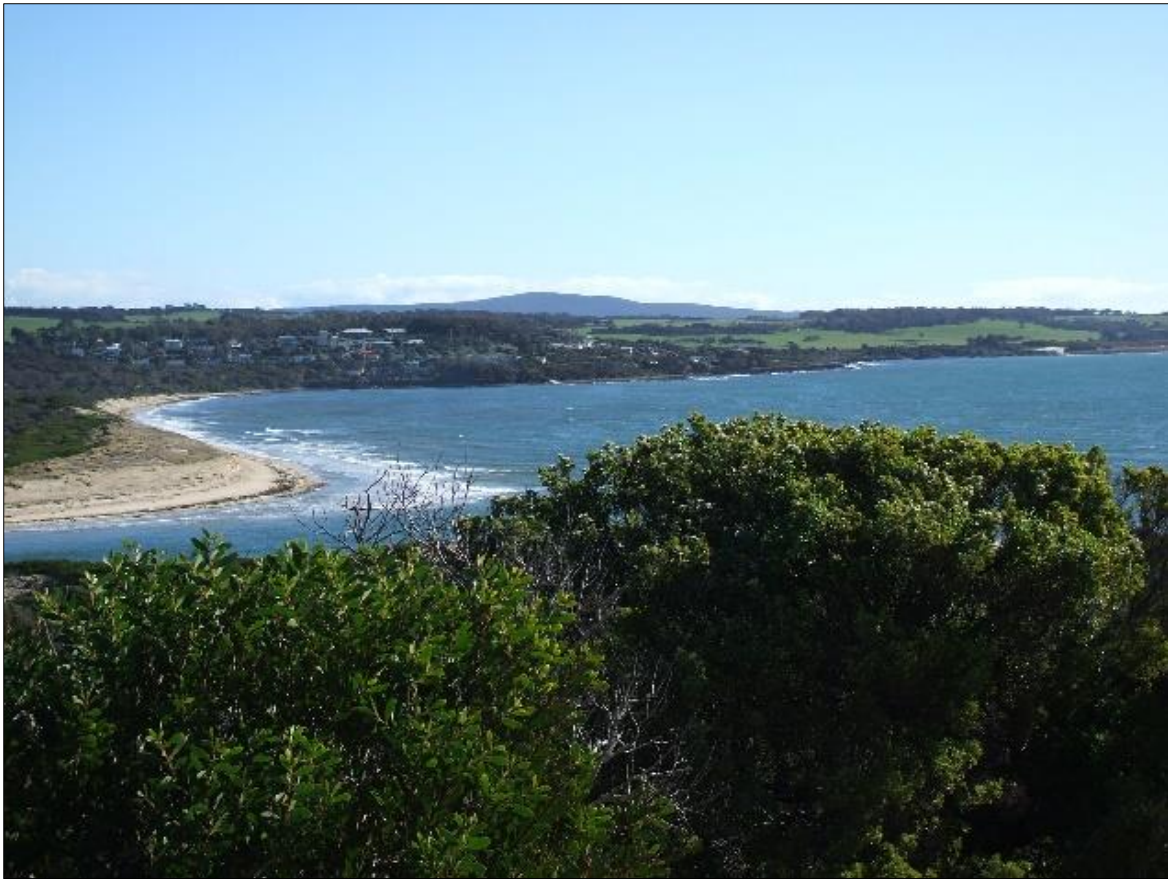
Figure 15: View of Weymouth beach from the Bellingham dunes (2007), displaying a steep slope of the hind dune into the high tide mark, courtesy of Lionel Cooper.

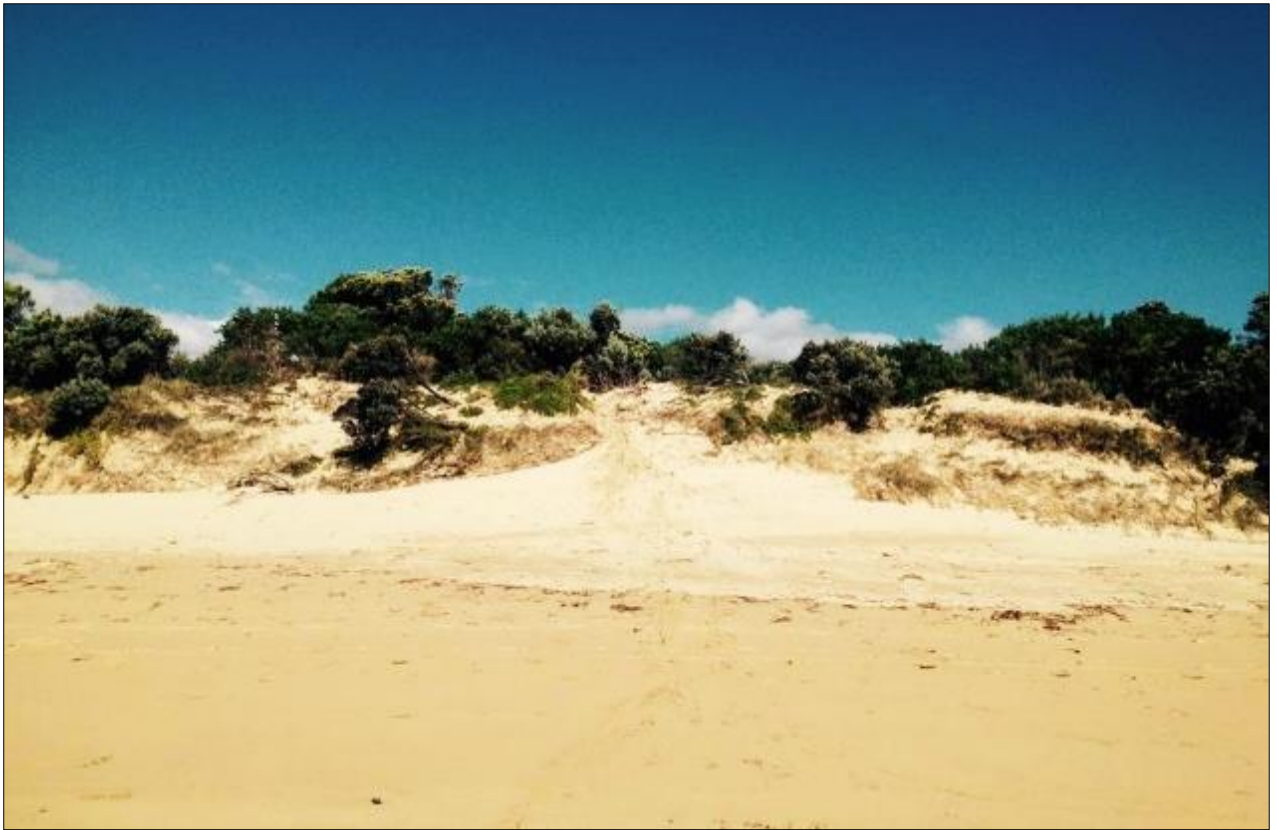
Figure 20: Photograph looking upwards of Transect 1 (2015), courtesy of Ian Sauer.

These transects (Figures 16-18 and Figures 20-22) display a contrasting transition from the hind dune to the low tide mark. Yet these transects remain comparable, without the conflicting presence of a major dune structure, such as a fore dune. As baseline data, these transects lay down the foundations for present and future studies for the quantitative analysis of WB geomorphology.

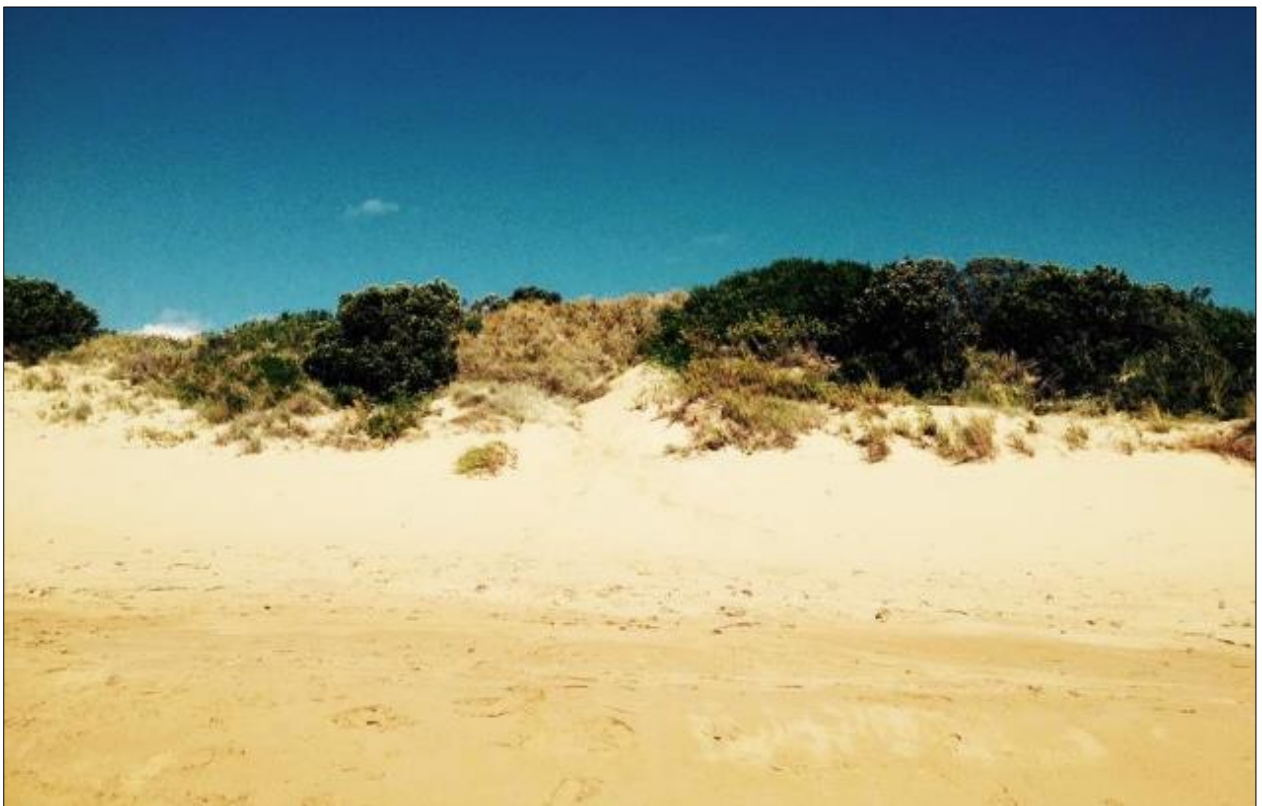
Figure 21: Photograph looking upwards of Transect 2 (2015), courtesy of Ian Sauer.

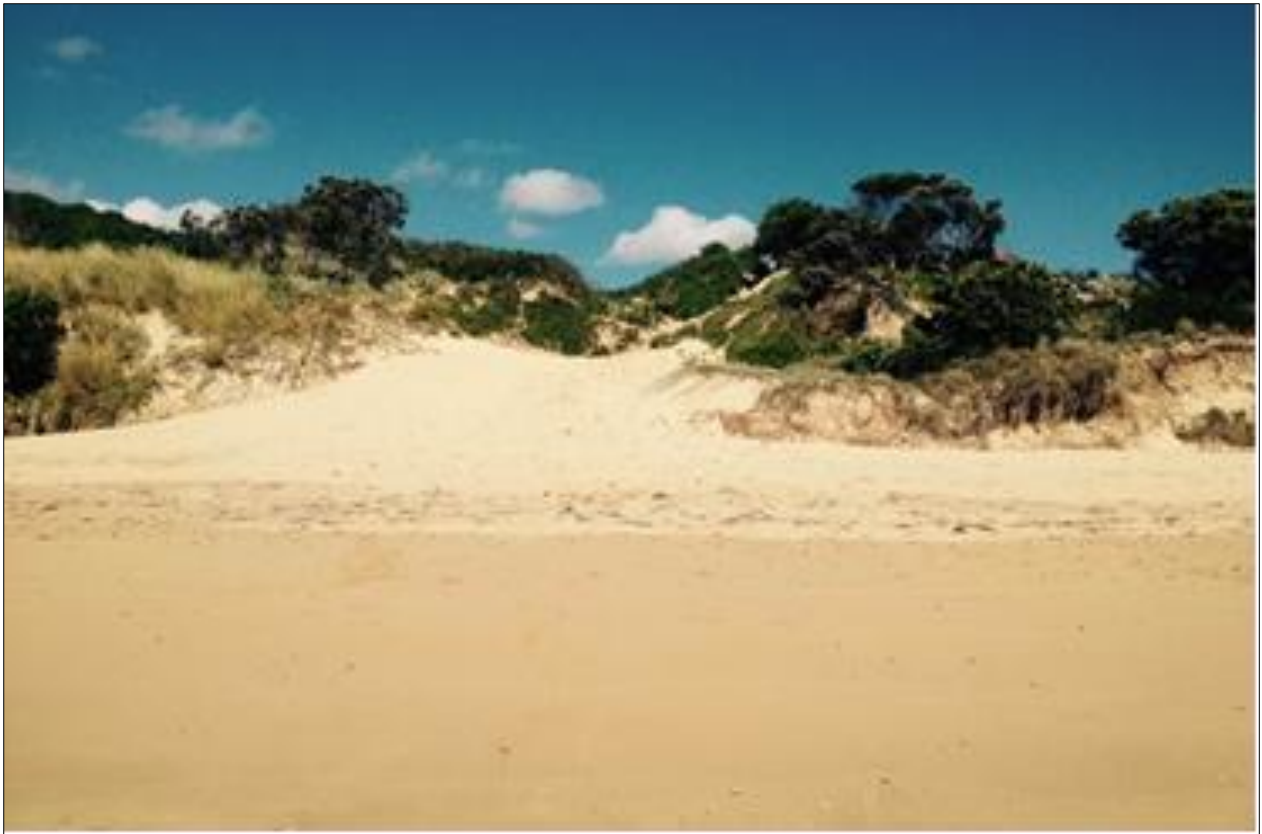
Figure 22: Photograph looking upwards of Transect 3 (2015), courtesy of Ian Sauer.

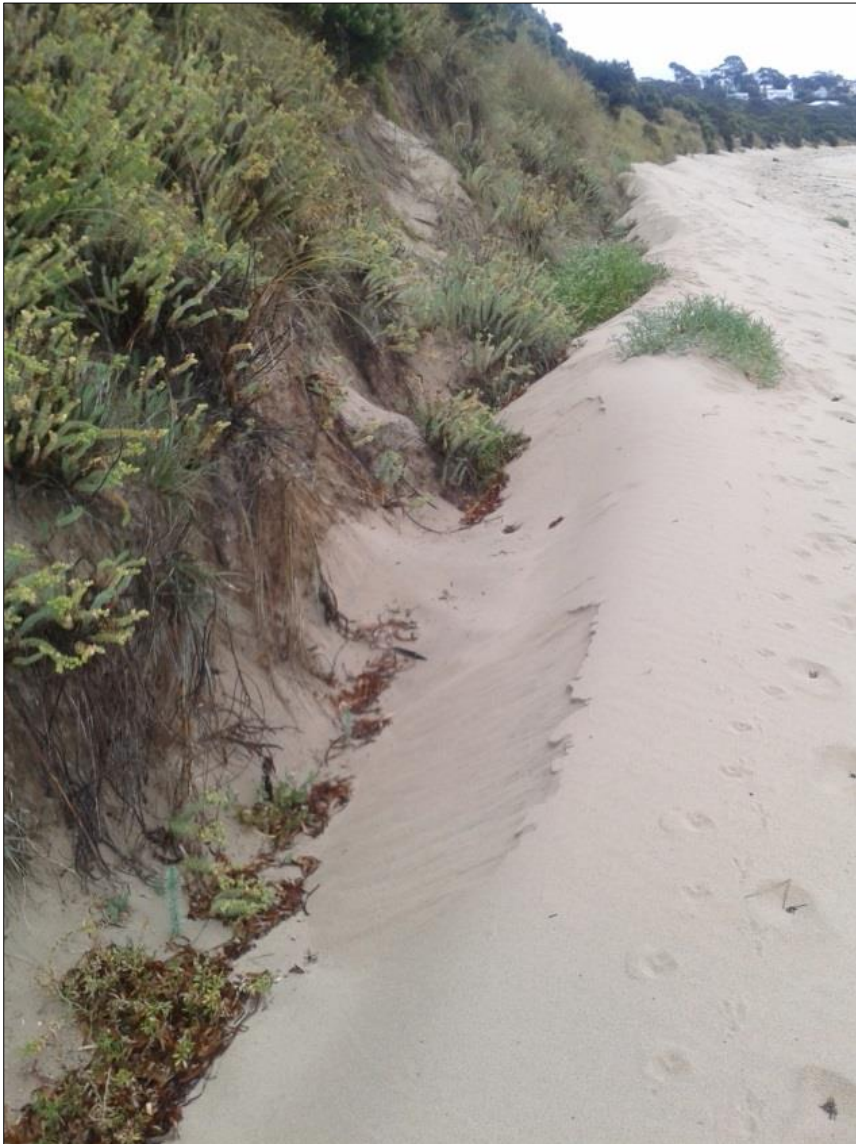
Figure 23: Transect 3 (24th of April, 2015) displaying the presence of pioneering, invasive species in the resulting minor dune of a recent storm event.

From what has been discussed previously, this gap is testament to the value of conventional landscape photography. This photography (Figures 23-25), is qualitative evidence for relating marram grass and other invasive species, to coastal instability. Figures 20-22 are also important in this gap, which depict the impact of vegetation trampling. The trampling of vegetation often leads to damage of vegetation (Schalcher et al., 2014 in Maslo and Lockwood, 2014, 60-69; Hayes and Kirkpatrick 2012; Johnston and Ellison 2014); vegetation trampling is known to increase vulnerability to erosion (Purvis et al., 2015; Johnston and Ellison, 2014). As discussed previously, in the absence of vegetation, dune sediment is bare and increasingly vulnerable to erosion. This is especially the case when directly contrasted against highly aggressive, highly sediment retentive species, such as marram grass.

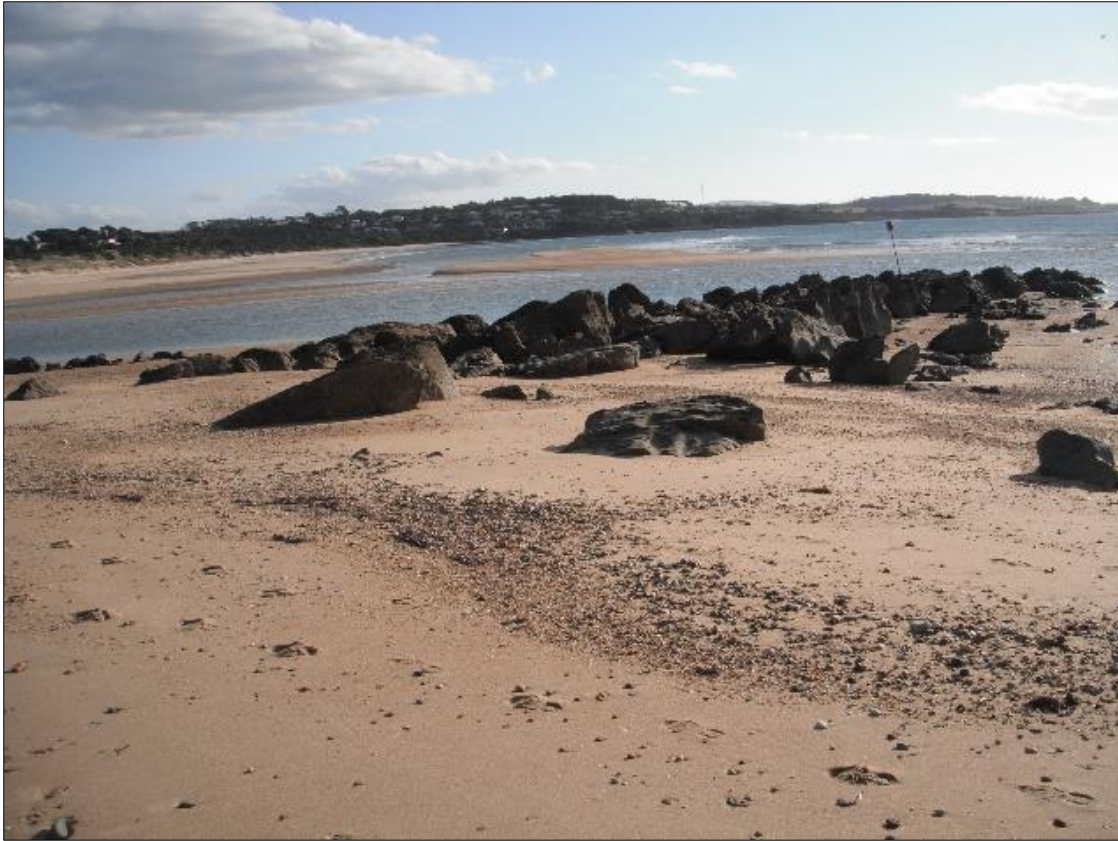
Figure 24: Reoccurring protrusion of rocks on the Bellingham side of the estuary mouth and the presence of a reoccurring sandbar that can often block out the estuary's mouth (17th of April, 2012), courtesy of Lionel Cooper.

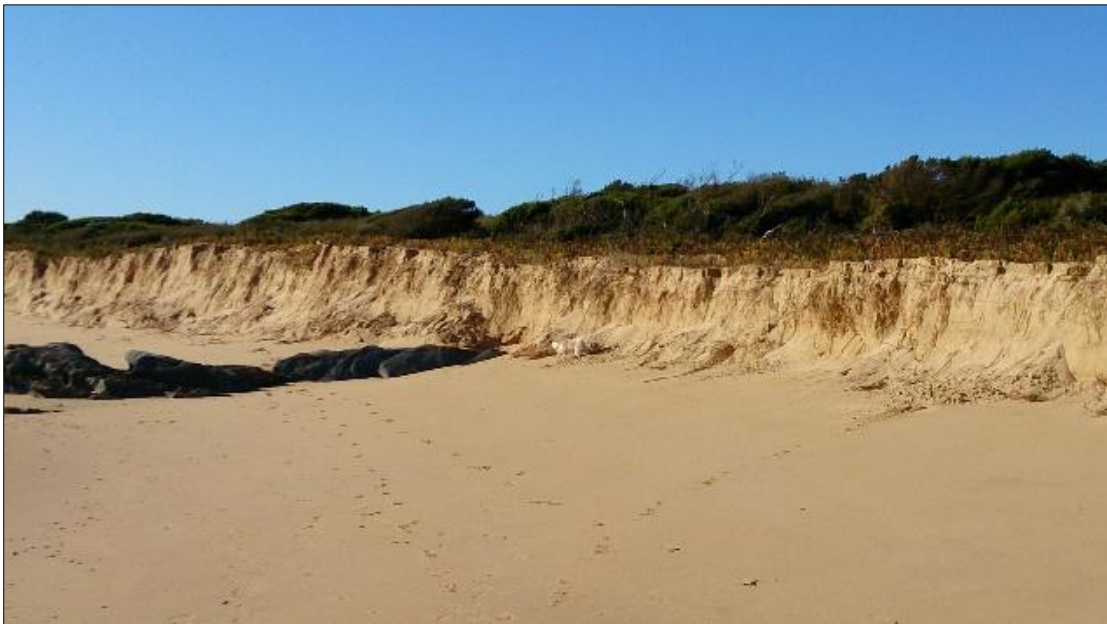
Figure 25: Erosion of the Bellingham dune (10th of July, 2014), contrasting the nature of erosion, derived from dune orientation, courtesy of Lionel Cooper.

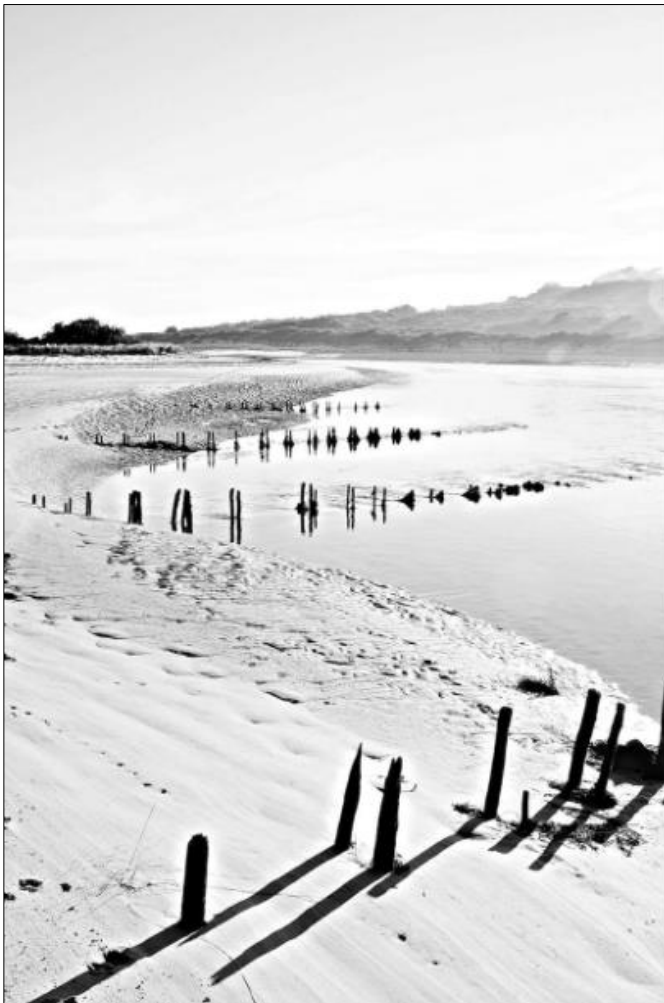
Figure 26: the remains of the groynes in the Weymouth/Bellingham estuary, facing towards the Bellingham dunes, courtesy of Lindal Byard.
