Assessment of Pipers Head beach characteristics

(October 2017)

Report for

Bellingham Progress Association

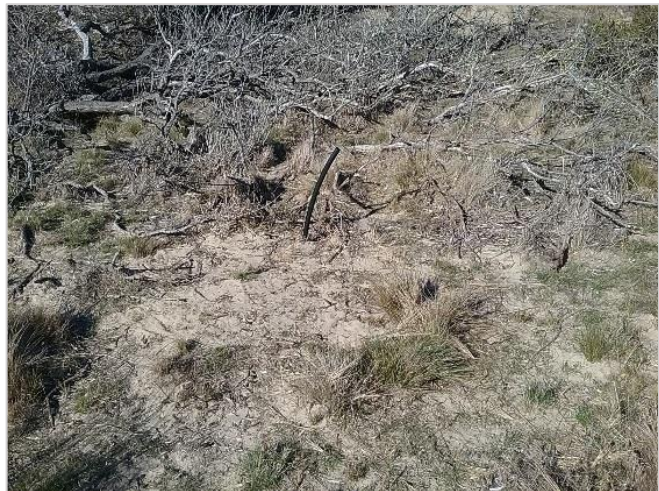
Figure 3. GPS marker in place, courtesy of Bellingham Progressive Society volunteers, photo by R Smith

A study area was reconnoitred and suitable positions for transecting dune and beach terrain were located and GPS coordinates were logged in, and volunteers from the Bellingham Progress Society helped create and establish semi-permanent markers at GPS points, (Fig. 3).

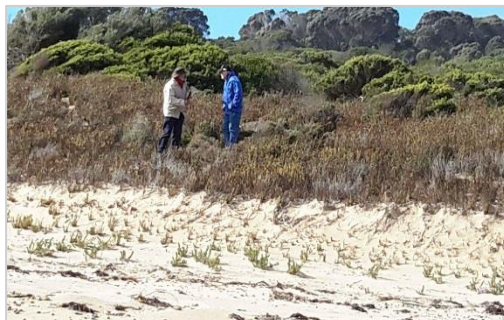
Figure. 4. Greg Morrison and researcher plotting GPS positions for study (photo: D Ballenden)

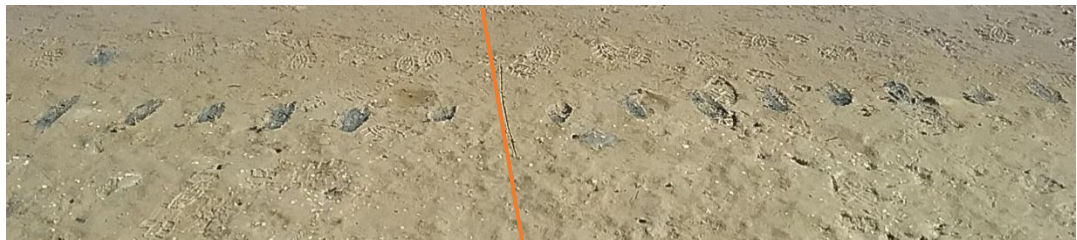
Figure. 5. Orange line is the transect line showing depth of sample procurement technique used to collect sediment sample, photo by R Smith

Soil sampling was achieved by collection, with assistance from two Bellingham residents, at three points along each transect. Starting at the foredune base, the transect was intersected by a line 90° on either side, and along these lines at ten intervals of 100 mm span, and a scoop of no more than 2 cm deep of sediment was then collected into a bag at each point. These soil samples were identified by transect and position along that line, then returned to the laboratory for analysis.

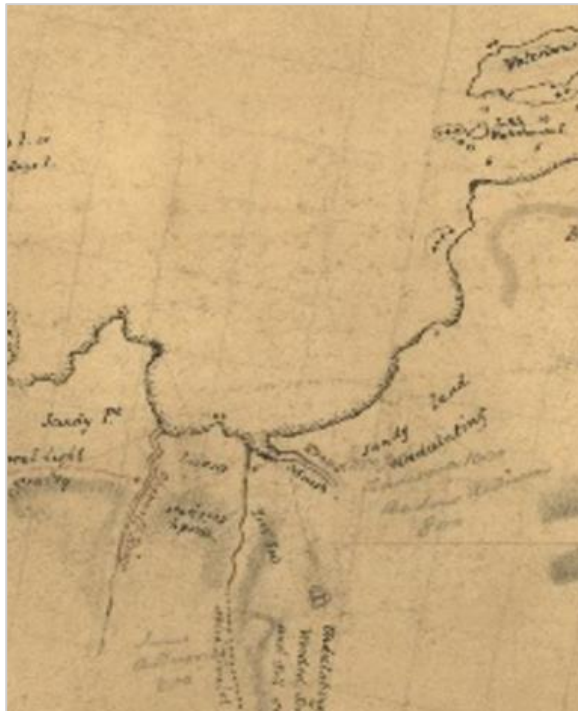
Figure 8. First known survey map of Bellingham, surveyor Mr Lewis circa 1810.

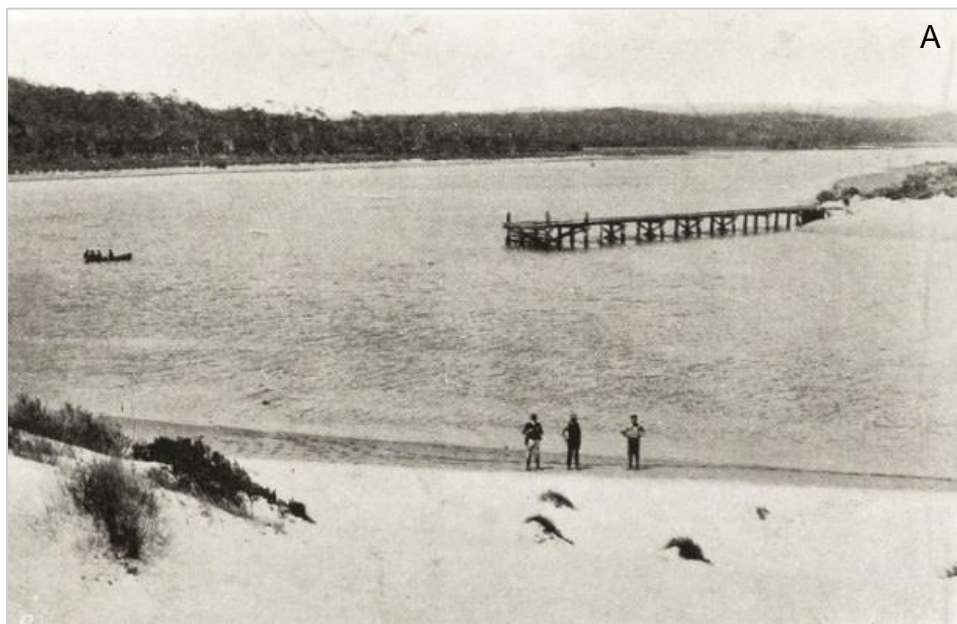
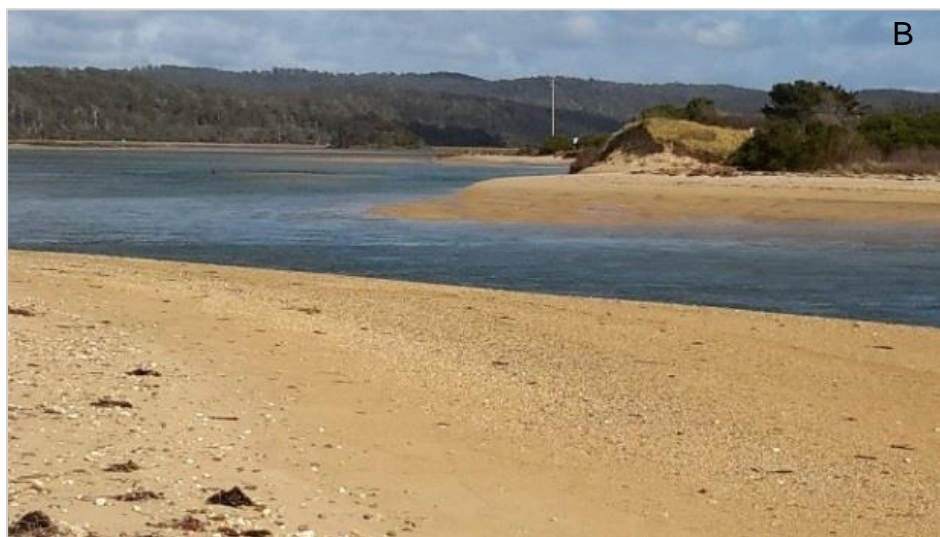
Fig. 9 A. photograph was taken in 1909, from the dune bank looking towards Bellingham, taking in the jetty and the point on the Weymouth side. The figures in the picture give a rough guide as to how high the dune bank was and how far into Pipers River Estuary the jetty protruded.

Fig. 9 B. photograph was taken in 2017 from the river bank on the Bellingham side; not an exact position, but it still shows the difference due to sediment movement.

Figure. 9. Comparison photographs between 1909, A, (photo: B Viney), and 2017, B, (photo: R Smith)

In 1957 a map was commissioned, (Fig. 12), which unfortunately, was proven false when compared with Fig 9. A & B which shows no jetty existing in 1940. Also, some land holders claim that they owned land there in 1970, not 1957. Still it does show what the estuary was like before 1940, with the dune system and an intact jetty at Weymouth.

As shown in Skinner (2015) Fig. 7 and Fig. 9 A & B of this report, by 1940 the river had its course changed towards the north, away from its westerly exit in front of Weymouth (1909). The remnant of the original river course and its usage are visible today at low tide with only one of the landward anchor posts of the jetty remaining, as circled in red in Fig. 30.

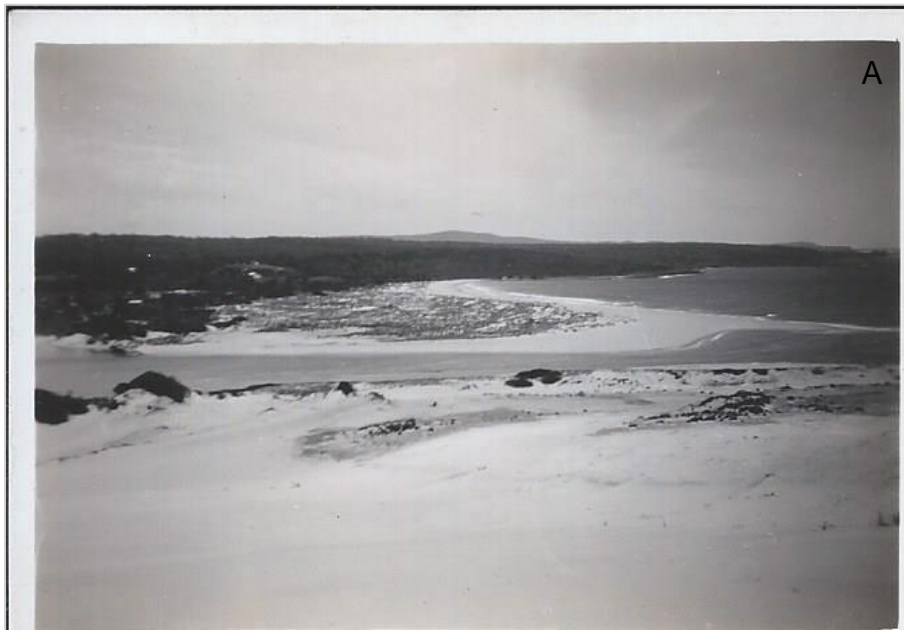
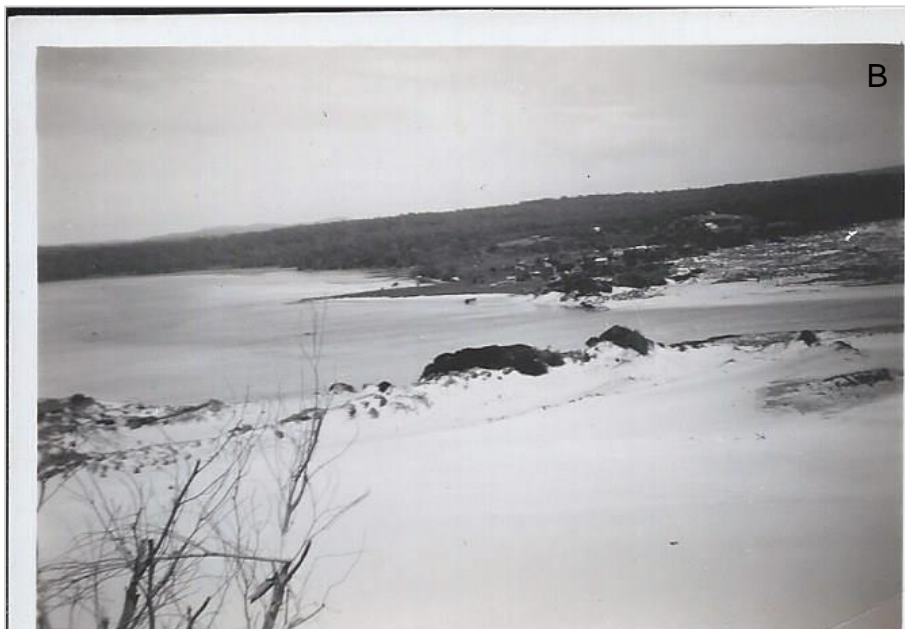
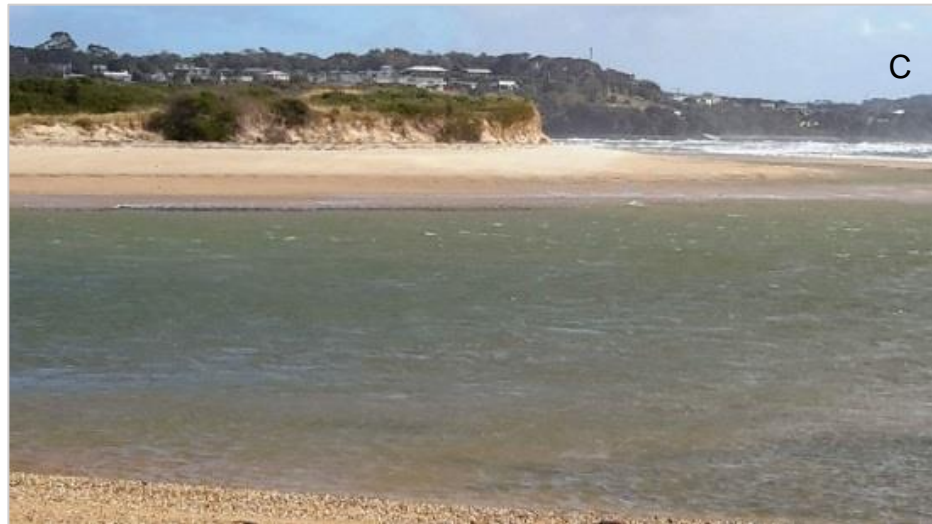
Fig. 11 A. 1940 photograph taken from Pipers Head dunes looking southward toward Weymouth, Fig. 11 B, taken on the same day, but looking westward, shows the low sand bar in front of the township and the river flowing in a northerly direction. Fig. 11 C. is a 2017 photograph for comparison with Fig. 11 B.

Figure. 11. Pipers River mouth showing new direction of river and sand. A & B from 1940, (Photo: B Viney). C from 2017 (Photo: R Smith)

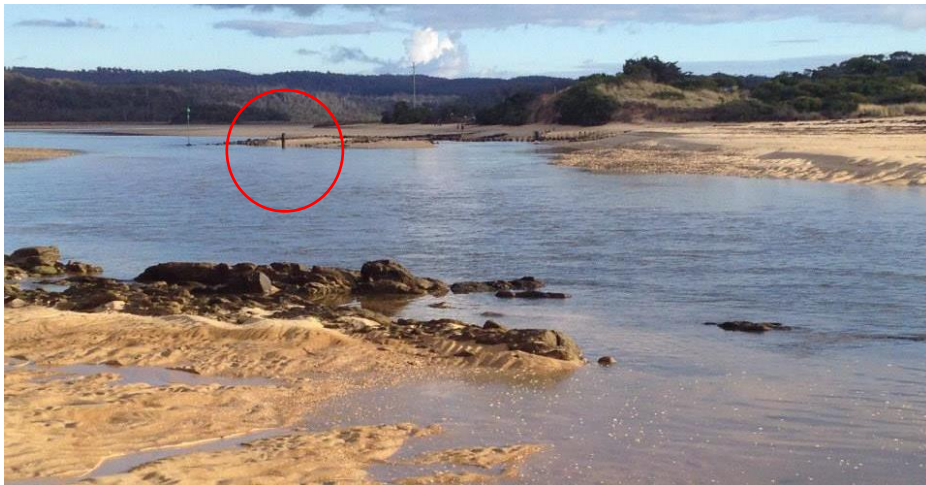
Figure 30. The only remaining jetty anchor post, circled in red, photo courtesy of B Viney

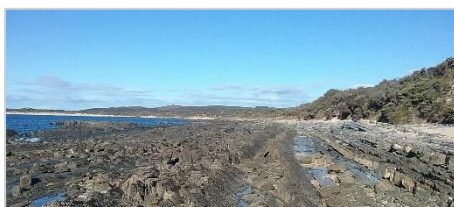
Figure 32. Part of Mathinna Bed formation on the northern shore of Pipers Head, photo by R Smith

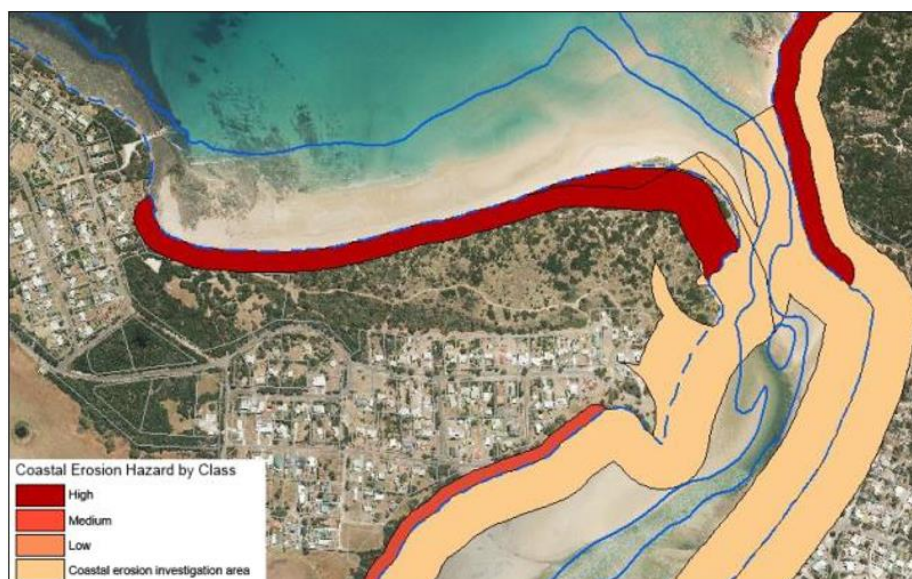
Figure 34. Coastal erosion risk, by class, courtesy of The George Town Council (Skinner, 2015)

Fig. 33 shows both transects 2 and 3 (Fig. 1) are within the red zone, which is where the greatest amount of hydraulic action is experienced, due to dominant wave energy direction into the river mouth. And with the position of the rock outcrop at Pipers Head, this funnels the longshore drift into Pipers River from the Weymouth beach, adding to the siltation of the estuarine and inhibiting estuarine vegetation growth. The depositing of fine sediment on top of large sediment, as seen in transect 2 results, (behind a rock outcrop), and as seen in transect 5, (furthest away from wave pressure), provides evidence of increasing siltation. At transect 3 at the tail-end of the red zone, there is a greater layer of fine sediment in the form of sand bars, depicting an accretion dominant period of sediment movement, (Thom and Hall, 1991).

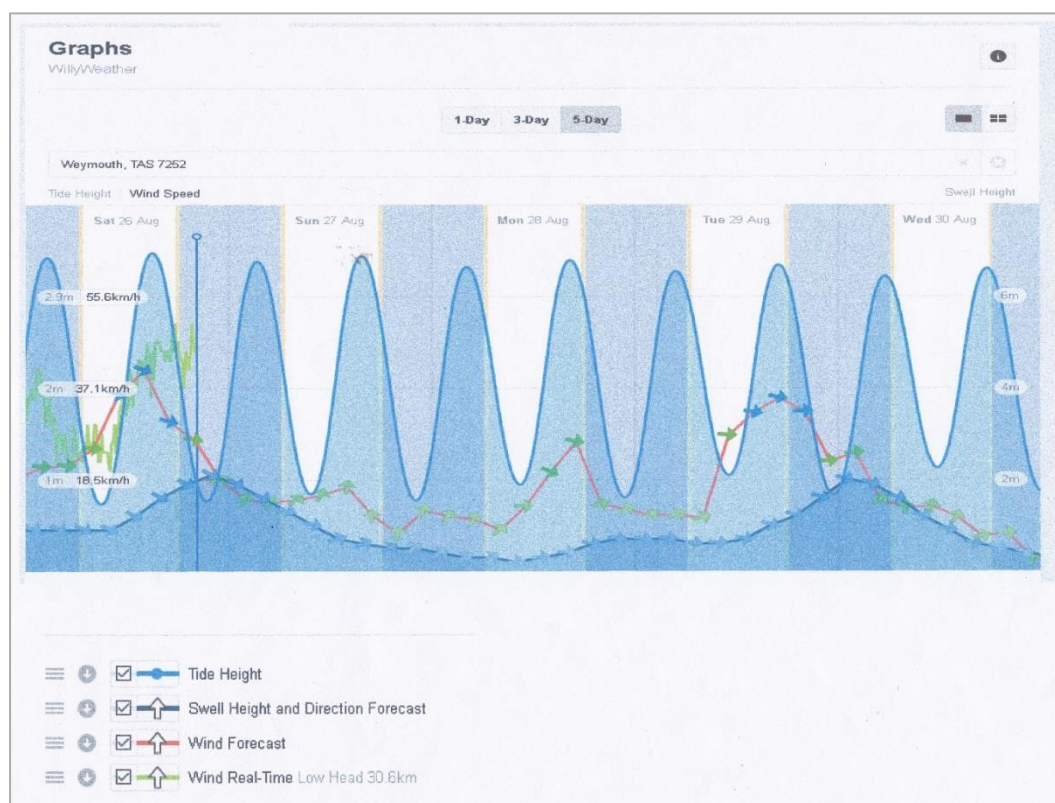
Figure 35. Willy weather report for the days of Aug 26th to Aug 30th, 2017. This was used as a local guide as it displays the Aeolian conditions
